336-005-RP1

# Flood Risk Assessment

Proposed BESS - Beauly, Inverness

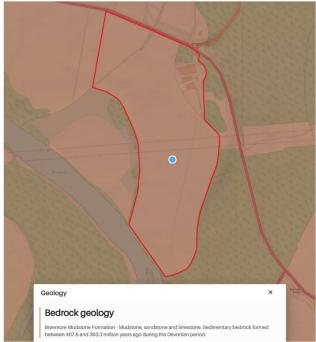
Figure 2: BGS Geology Map of Bedrock geology

British Geological Survey (BGS) mapping confirms the site to have a bedrock geology of Braemore Mudstone Formation being a combination of mudstone, sandstone, and limestone (see Figure 2). The superficial deposits for the site are shown to be Raised Marine Beach

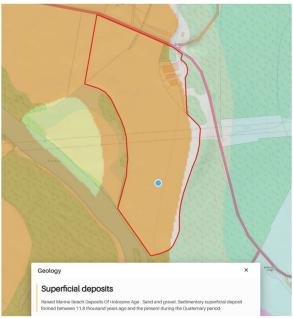
Figure 3: BGS Geology Map of Superficial deposits

Deposits of Holocene Age being a combination of sand and gravel (see Figure 3). There is a small section of the site where the superficial deposits are unknown.

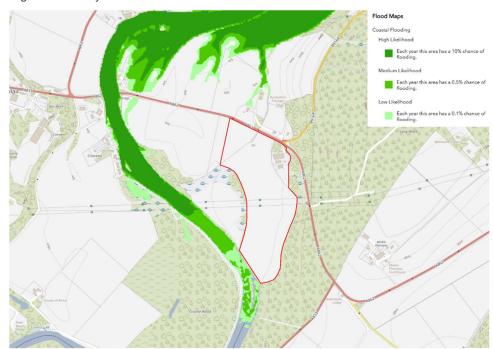
Figure 4: SEPA Flood Map - Coastal Flooding

The site is approximately 4.7 kilometres (km) away from the coast in a north-easterly direction. Coastal flooding could affect areas in the close vicinity of the site boundary as the River Beauly (that runs on the southern boundary) leading to the Beauly Firth and adjoining Inner Moray Firth is tidally influenced. The tidal flooding does not enter the site boundary.

The site is at low risk of flooding from tidal sources.

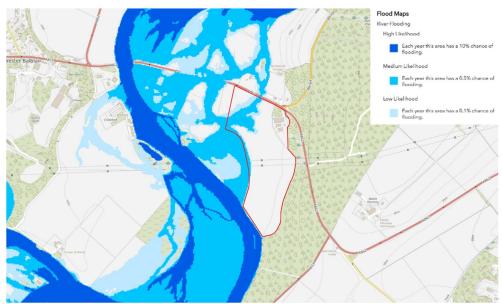
Figure 5 - SEPA Flood Map - River Flooding

The River Beauly runs adjacent to the southern boundary of the site and a short distance from the western boundary. There is low (classified as 0.1%) and medium (0.5%) associated flood risk, linked with this watercourse. The topography of the site is such that it falls from east to west with the western boundary being slightly above flood levels except for a small area in the north where there is a medium flood risk (See Figure 5).

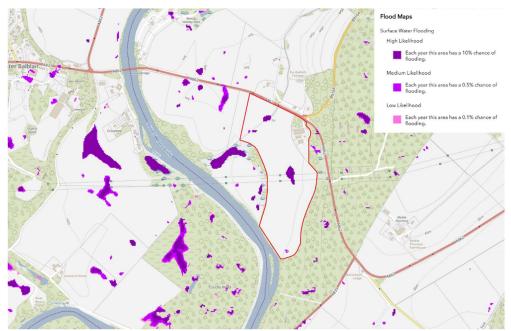
Figure 6: SEPA Flood Map - Surface Water

The SEPA Surface Water Flooding map (see Figure 6) shows the site and majority of the surrounding area to be at a very low risk of flooding from surface water.

OS mapping contours show surrounding ground levels to generally fall from east to west. The eastern most half of the site is located at a local high point with the upstream catchment comprising greenfield land and is shown to include marshy, grassy land; the rate and volume of surface water likely to be shed towards the site from this direction is considered to be minimal and the topography does not create a valley line to channel flow towards the site. The levels across the site undulate and therefore surface water could pond in the lower areas; this is shown and confirmed on the SEPA Surface Water Flooding maps.

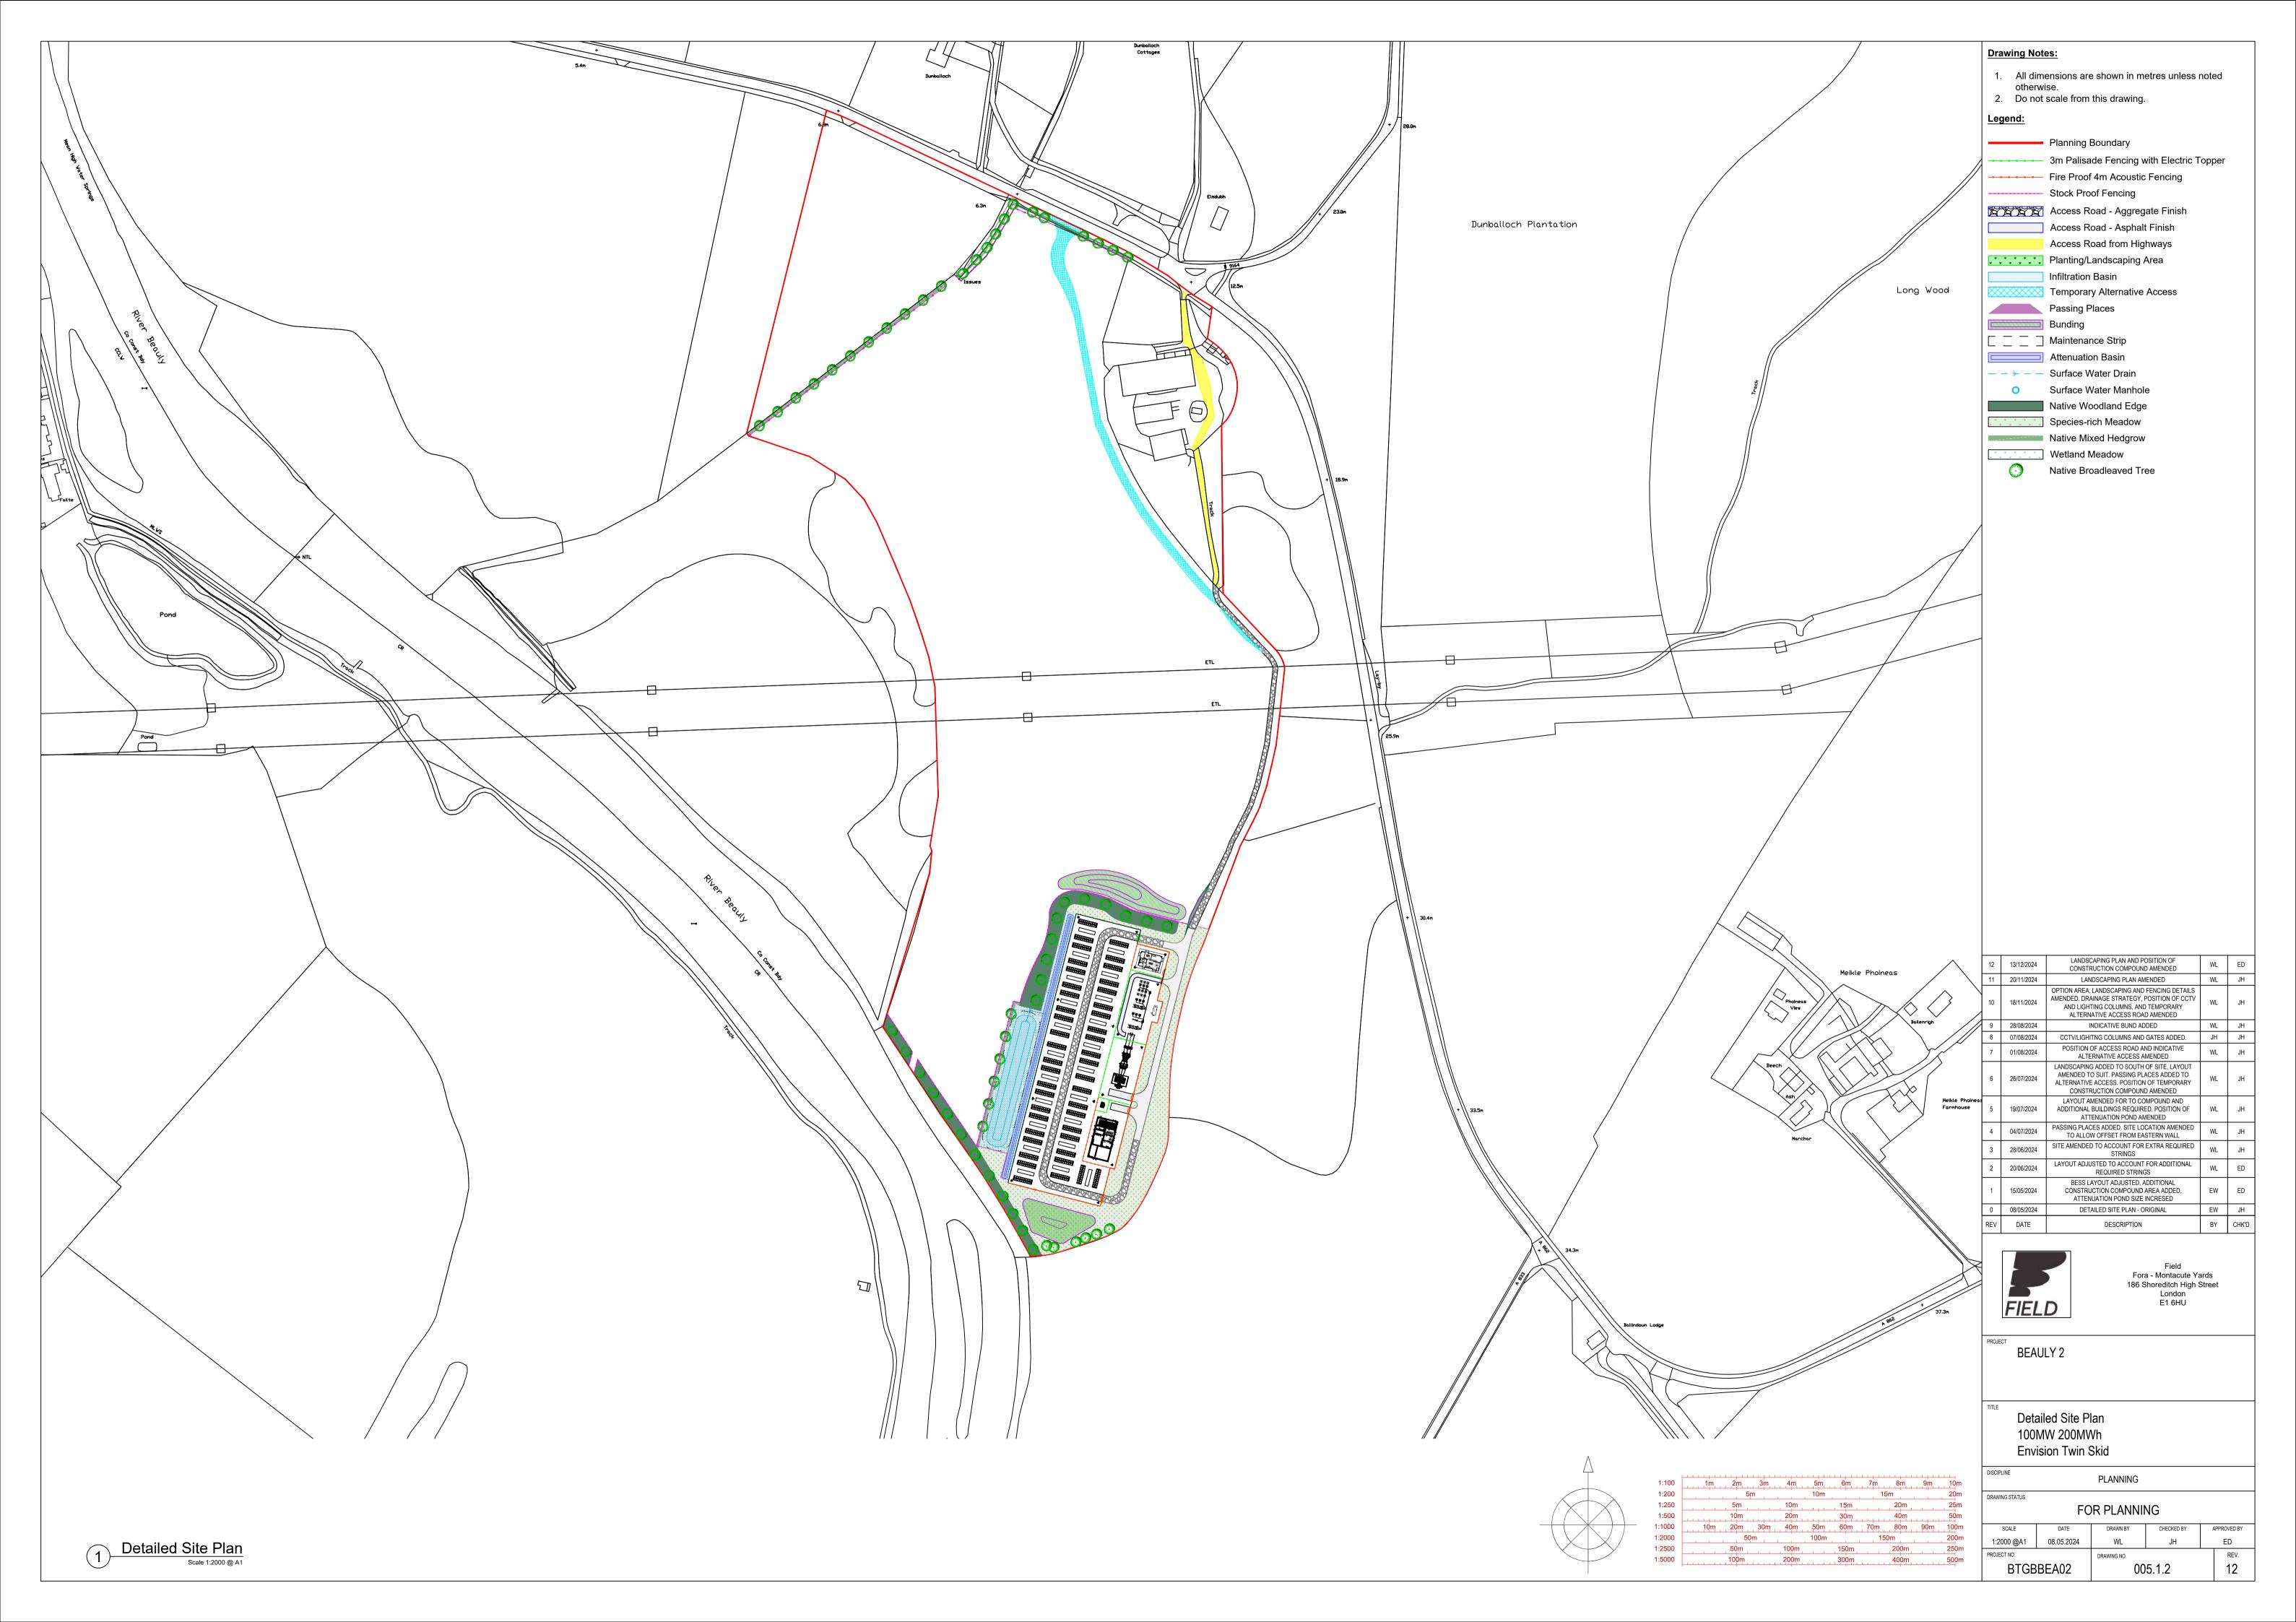
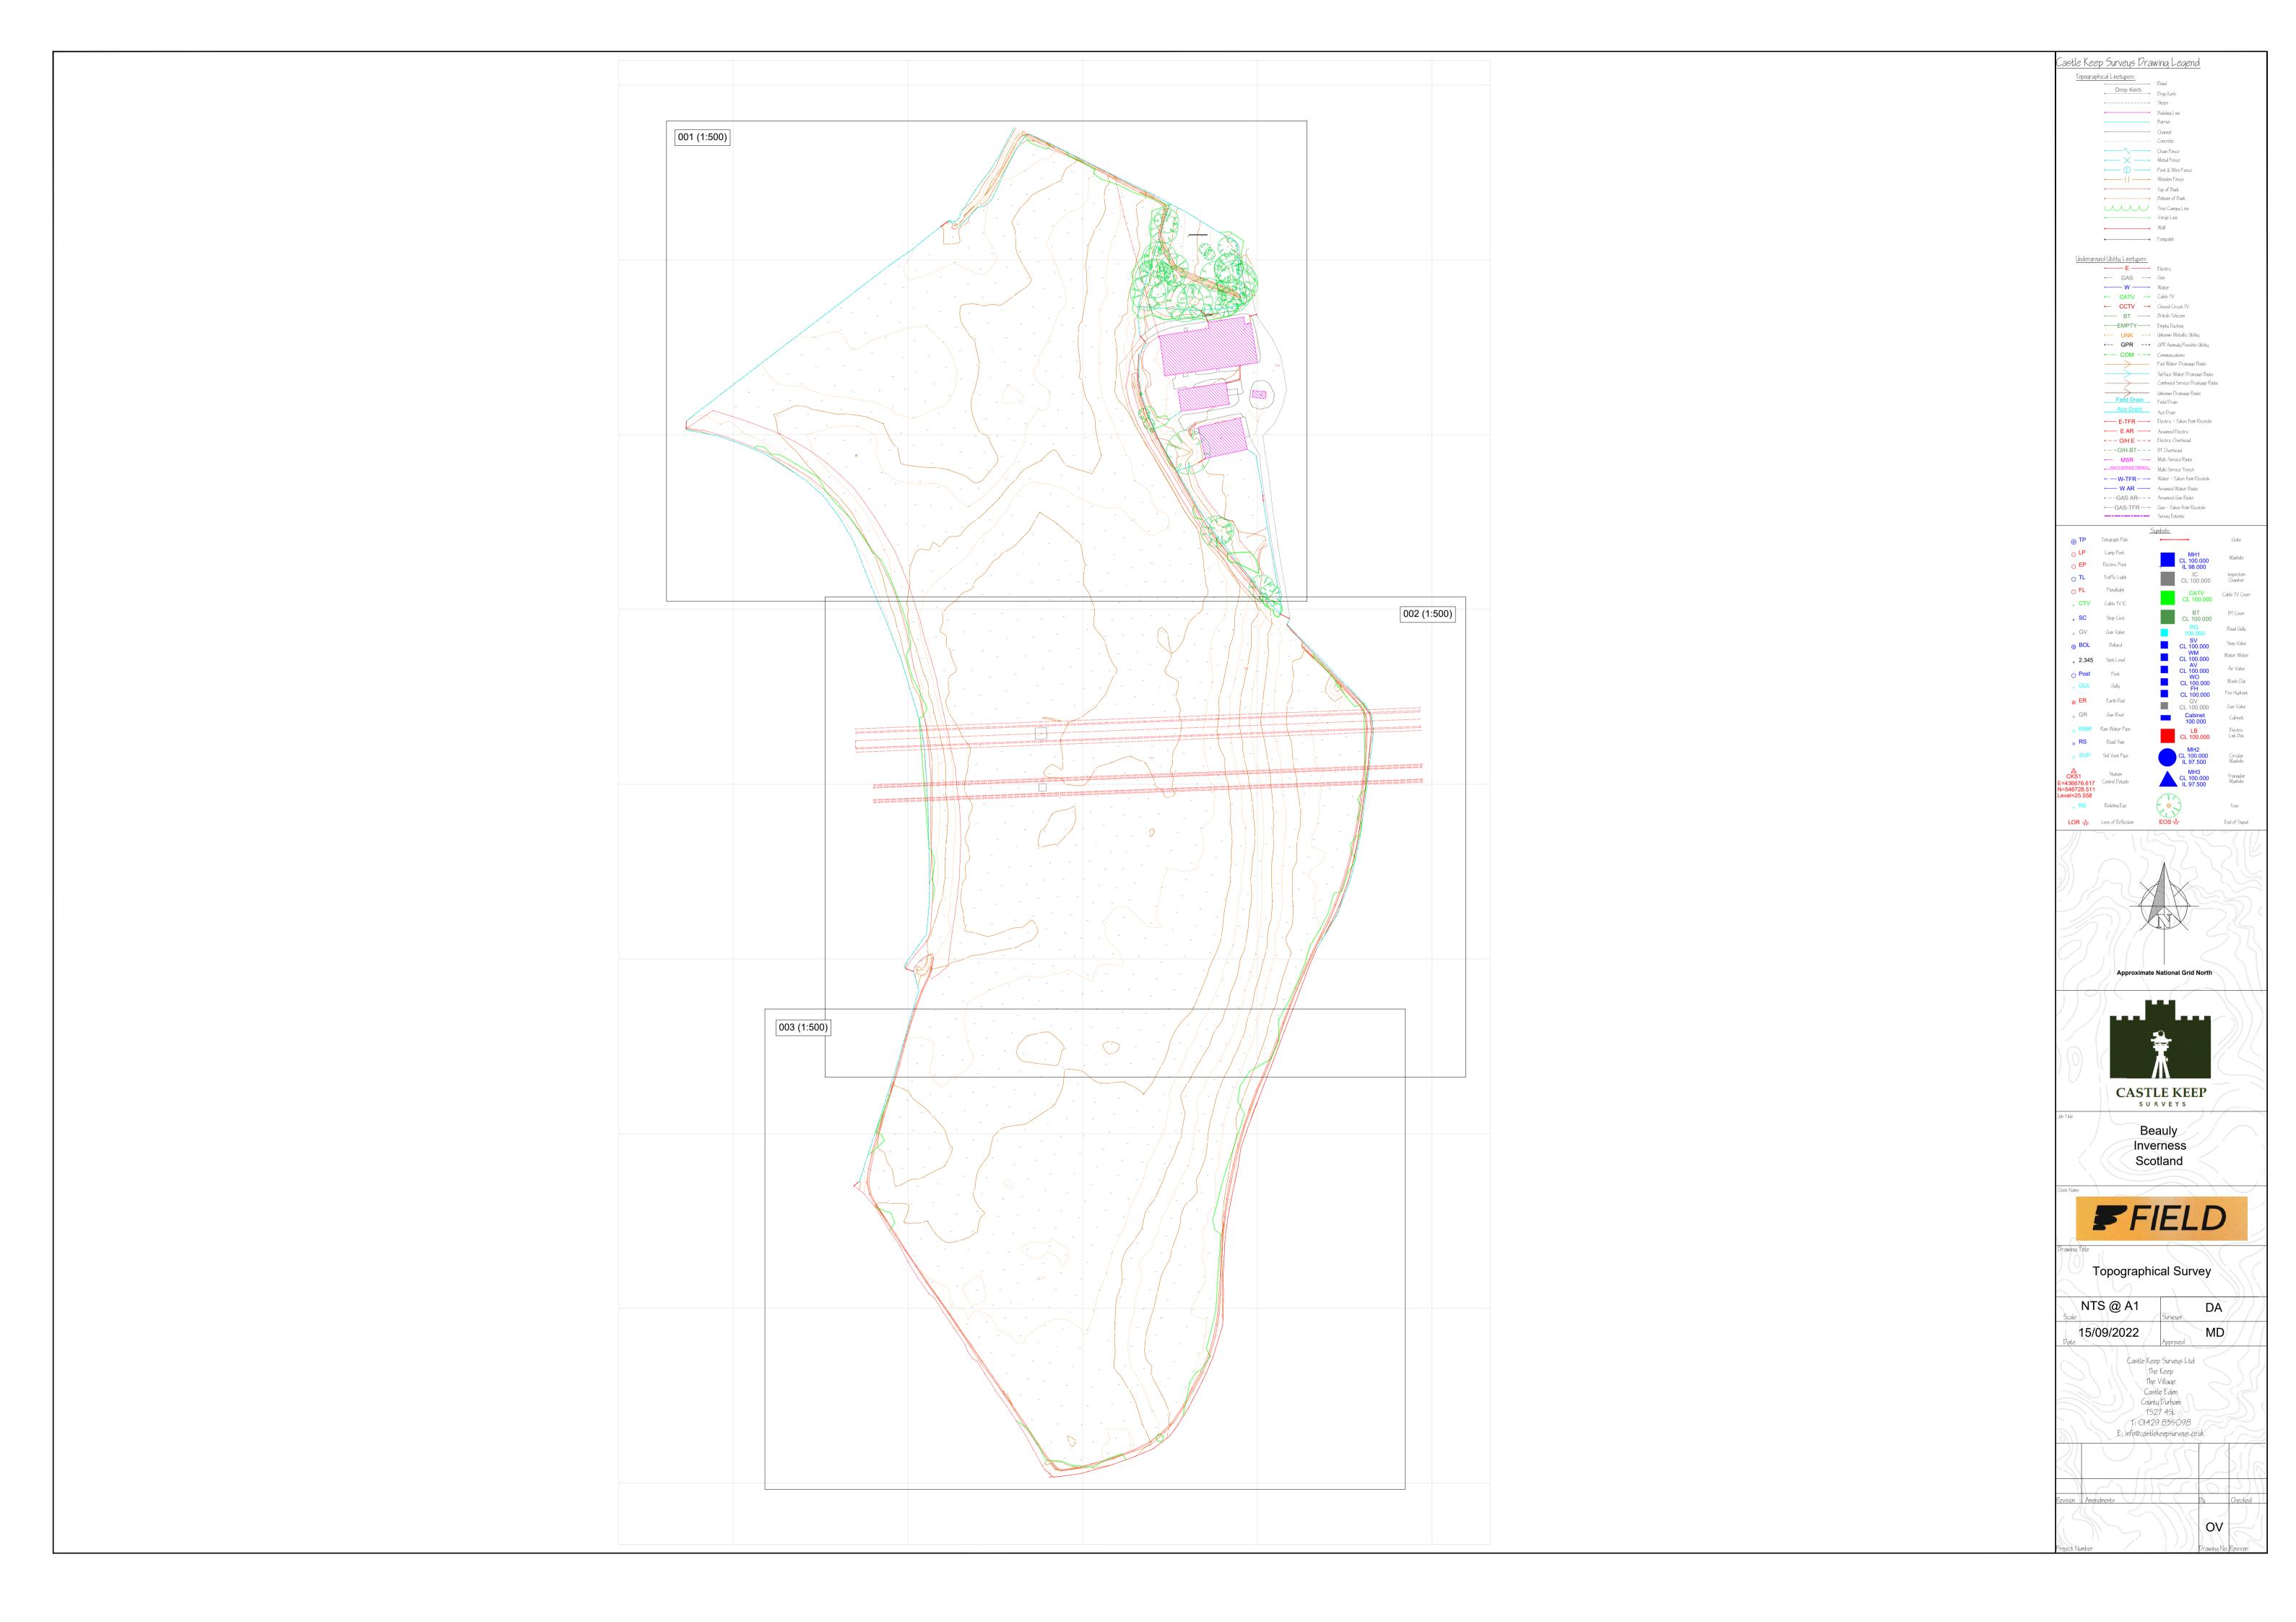
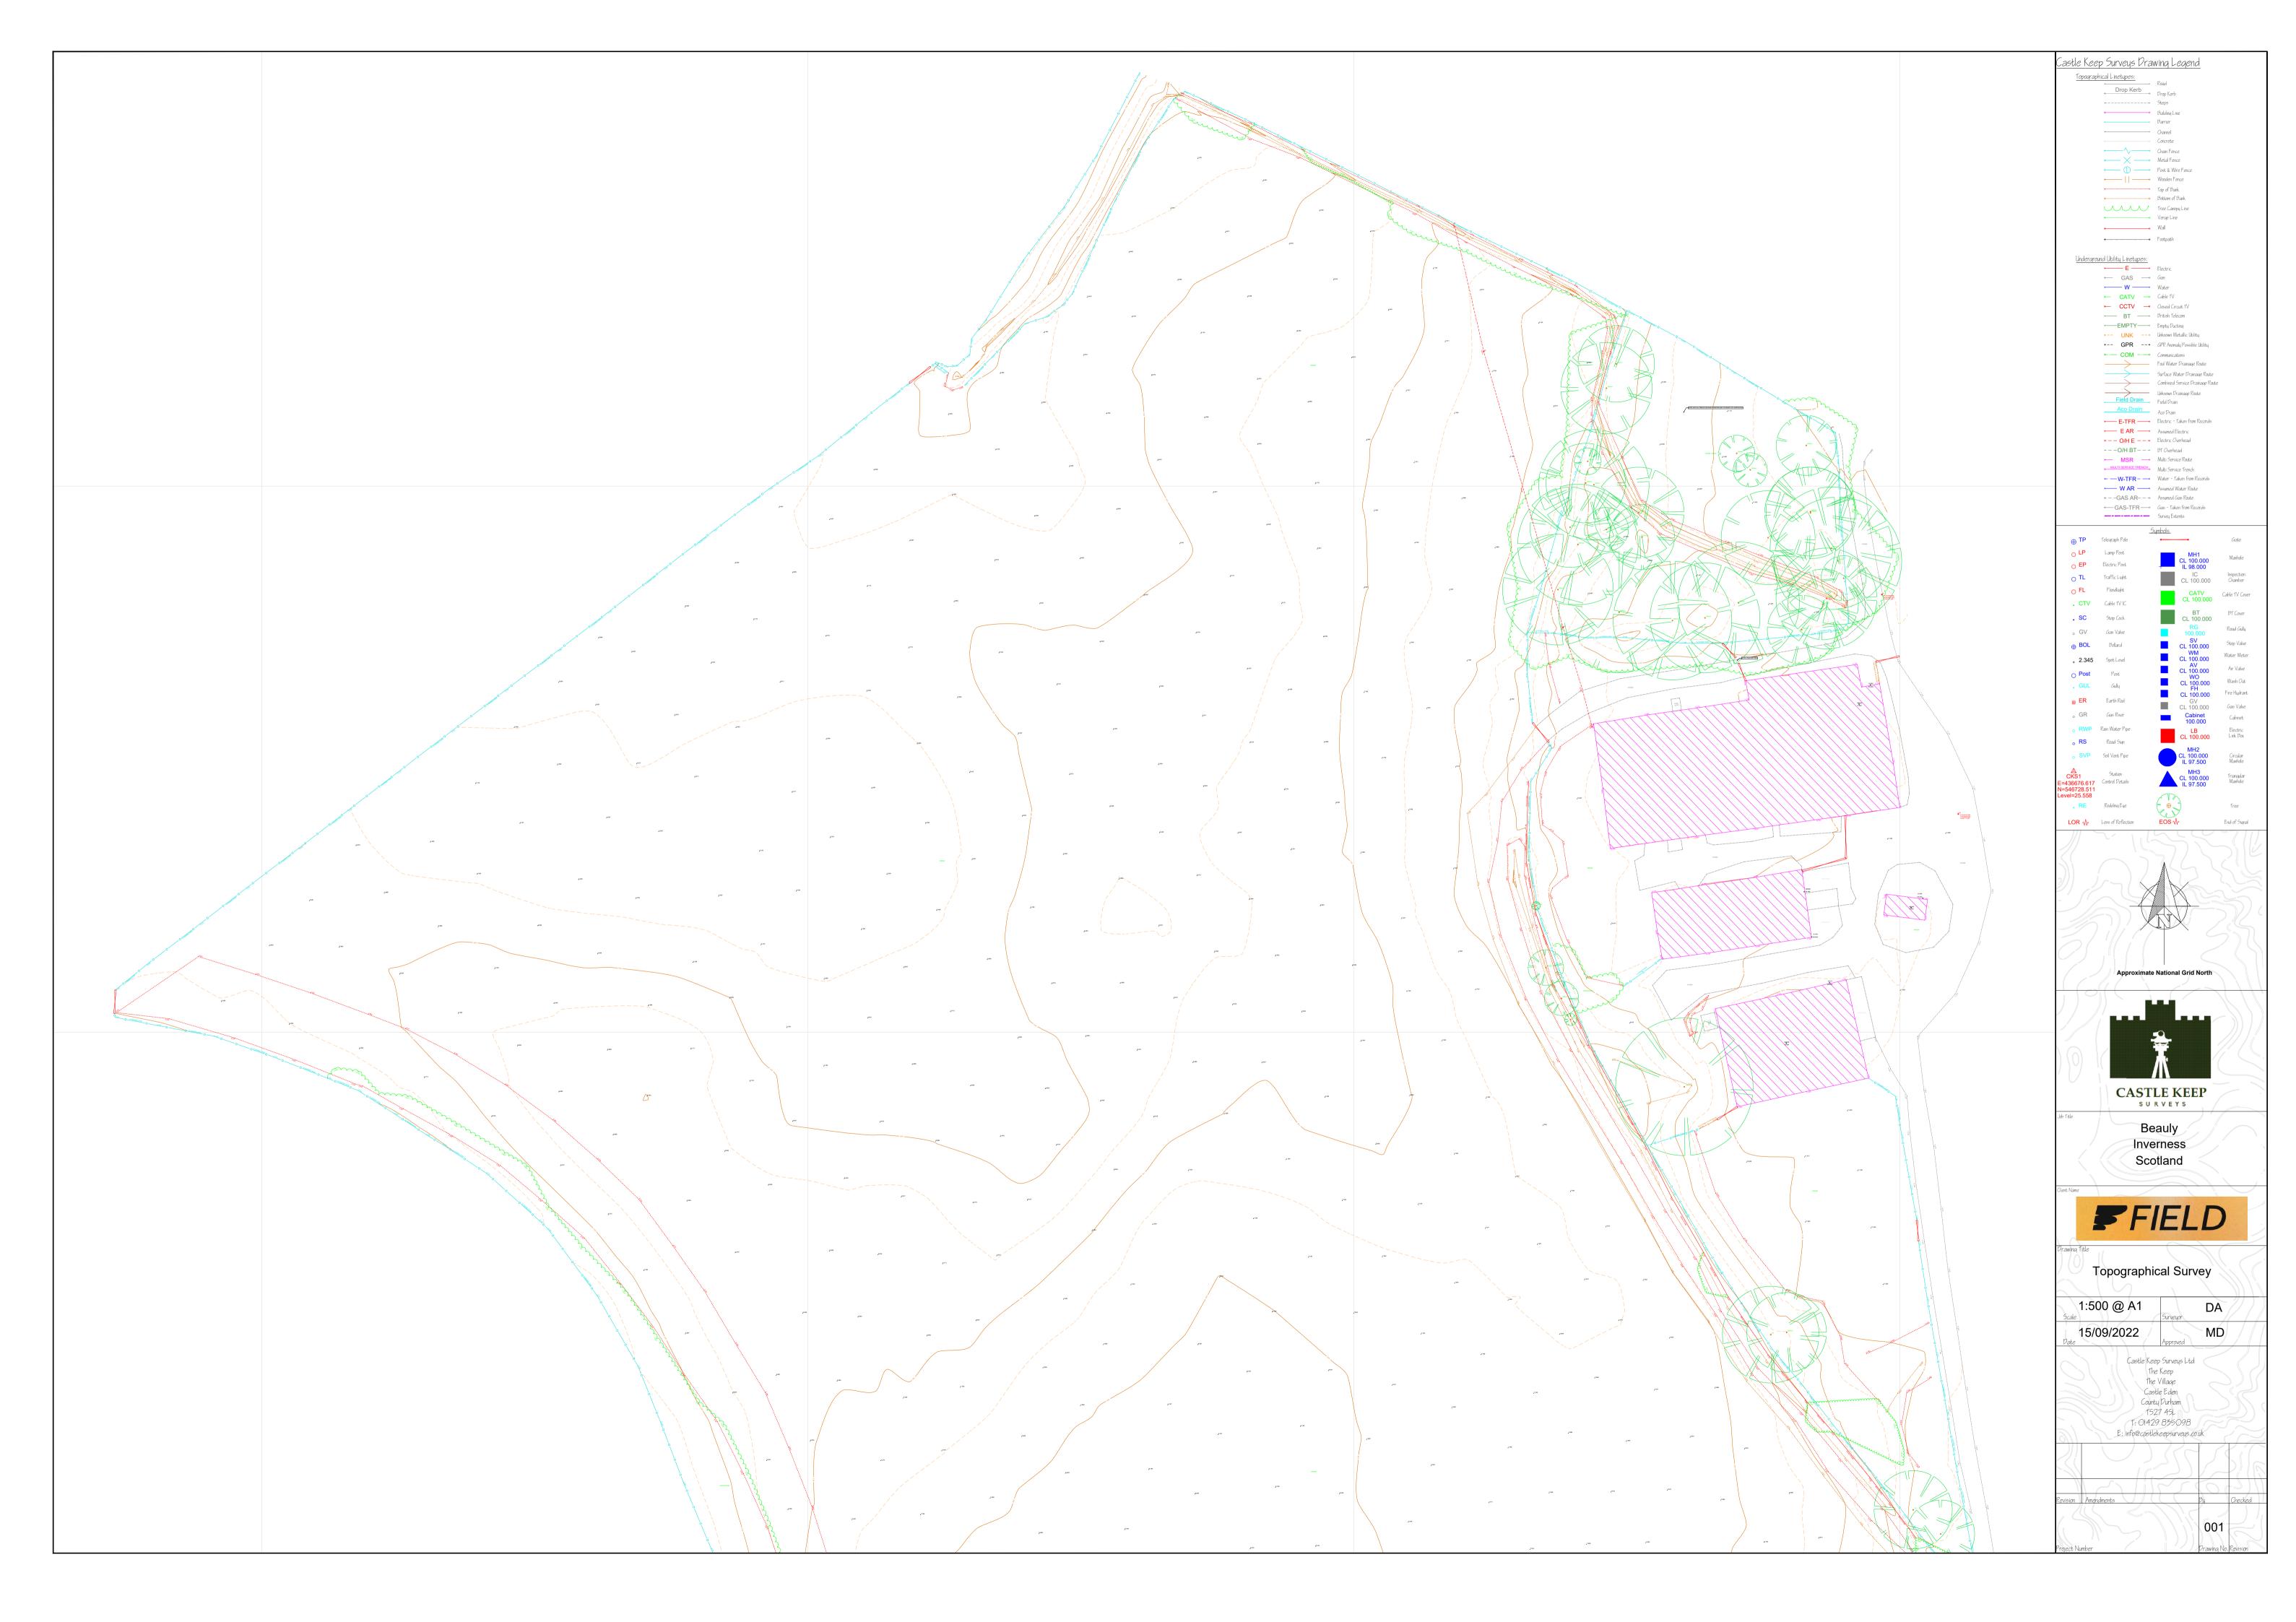
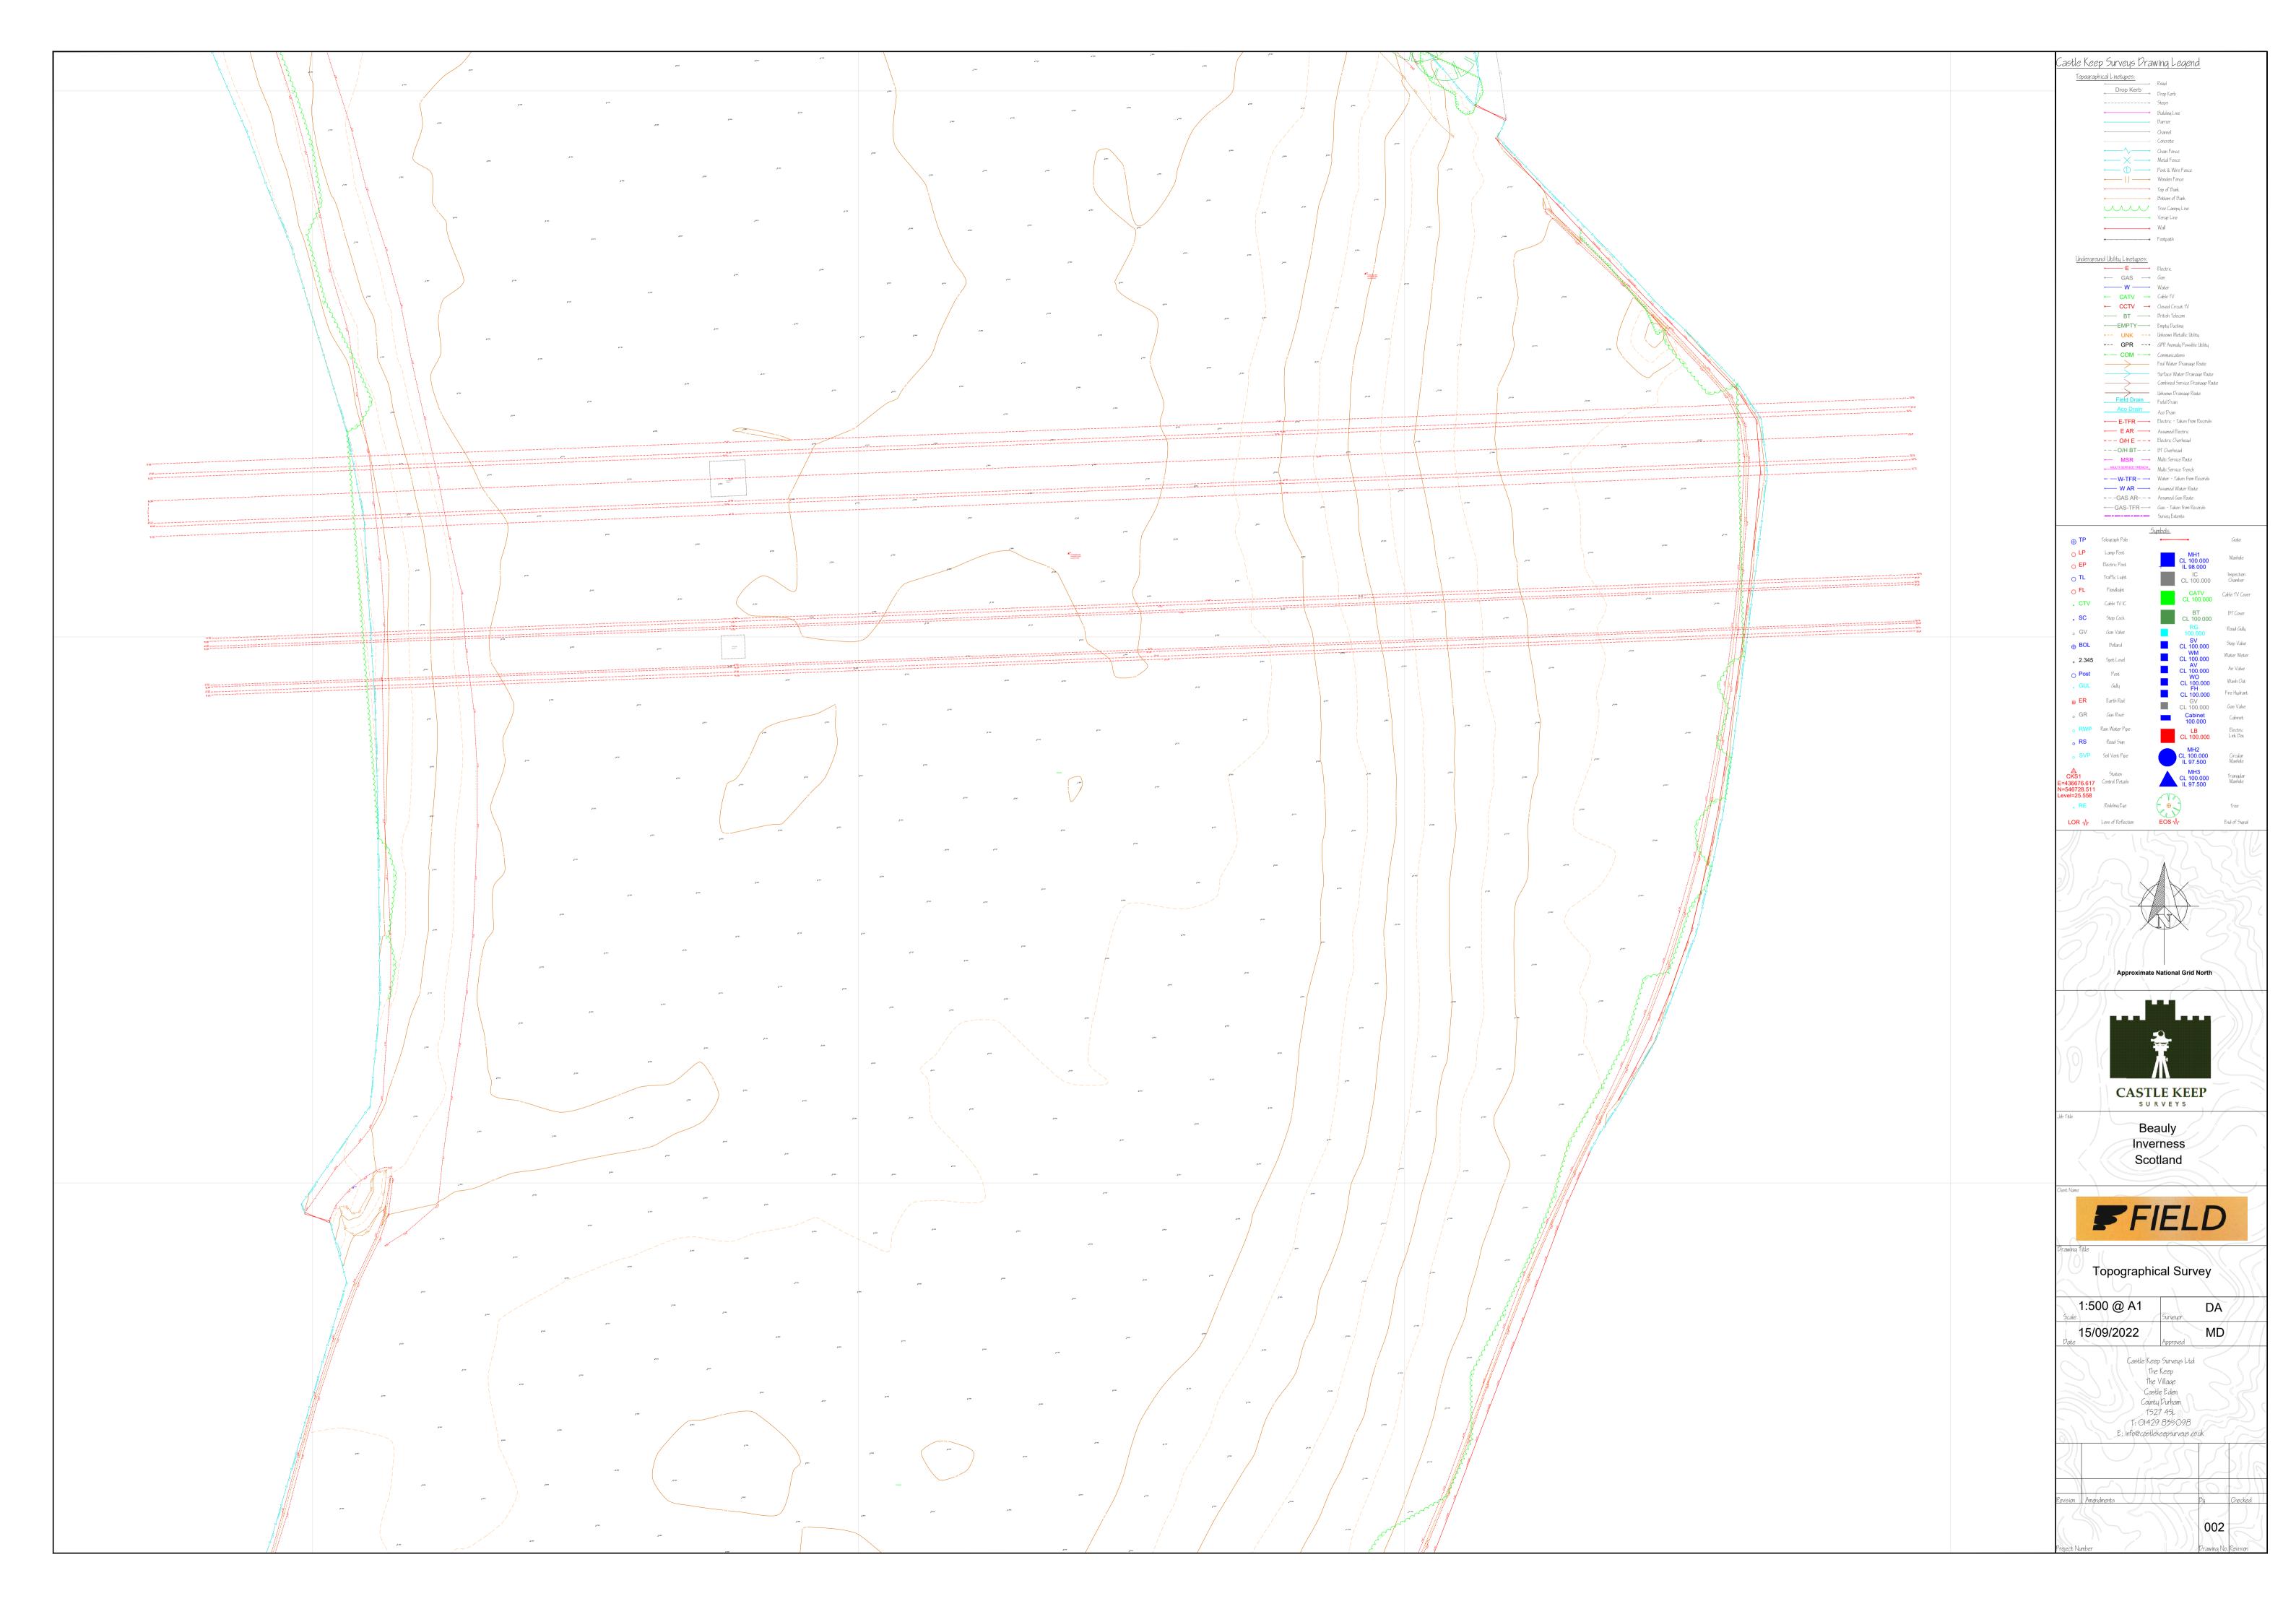
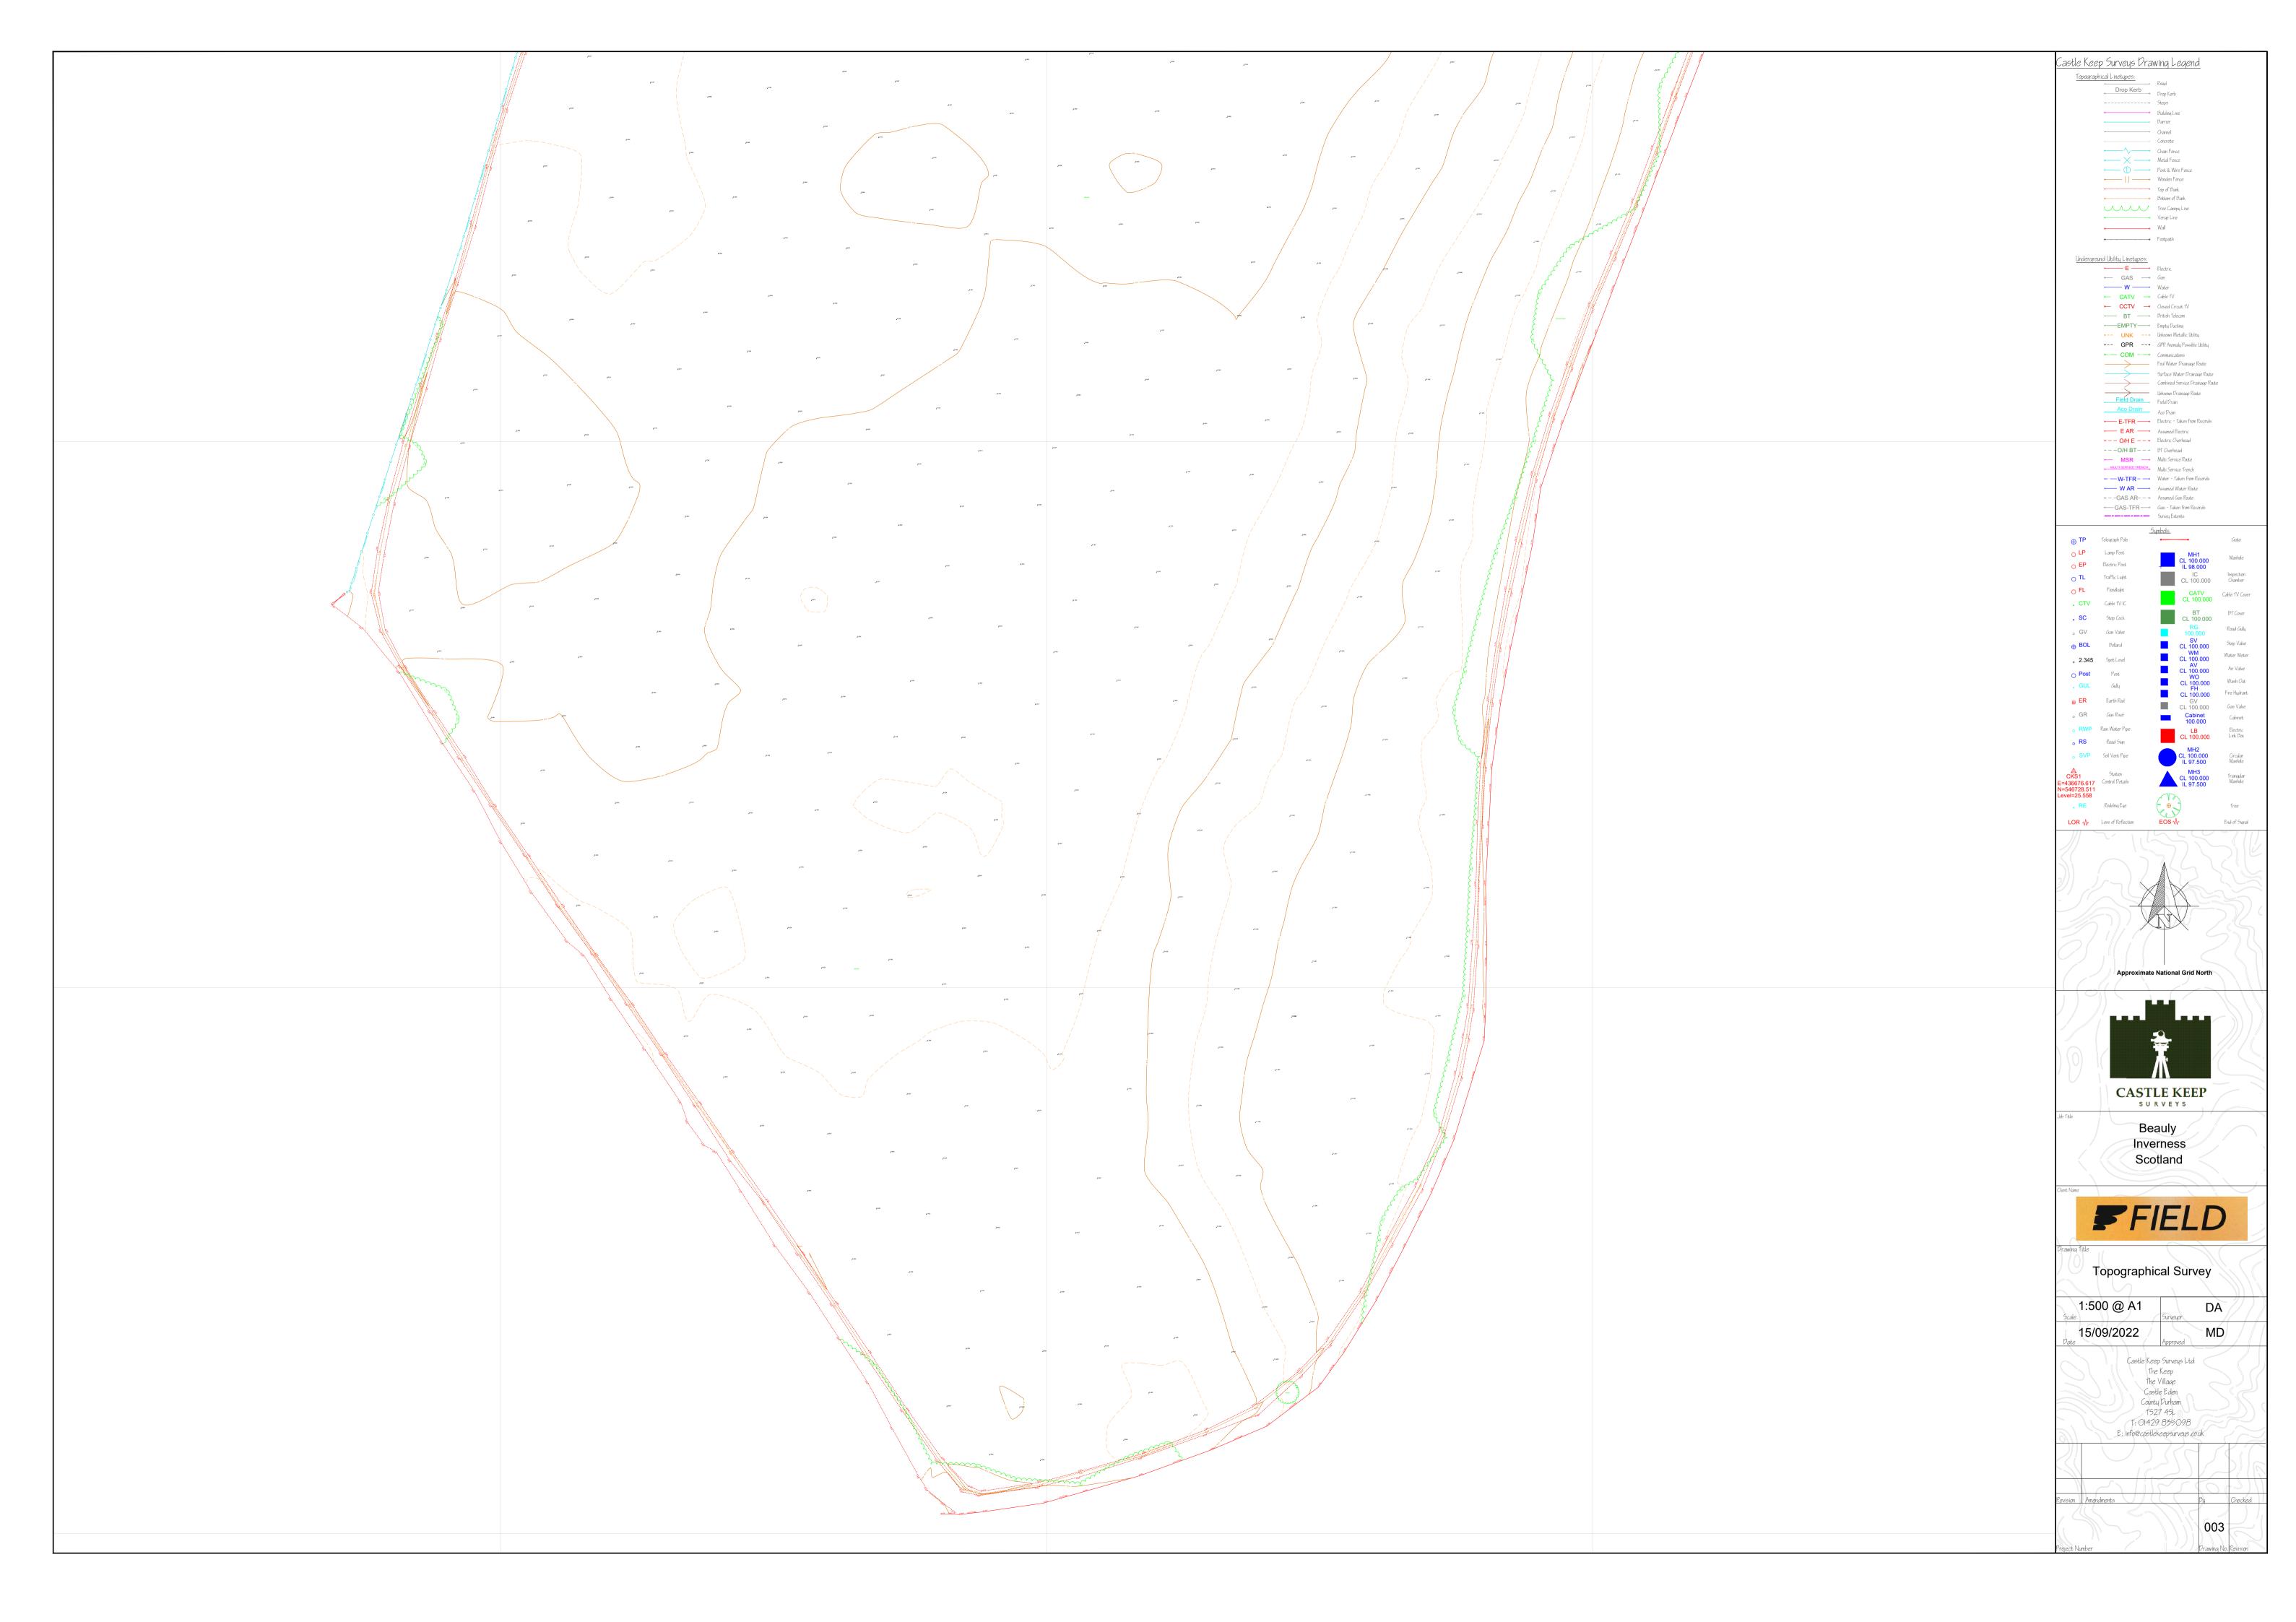
Topographical Survey by Castle Keep Survey - 290921 Beauly 02-OV

A topographic survey has been produced for the site (Appendix A). The survey shows ground levels to fall from east to west. Ground levels in the east are circa 12.7 metres Above Ordnance Datum (mAOD), falling to circa 5.2 mAOD in the west.
