336-005-RP1

# Flood Risk Assessment

Proposed BESS - Beauly, Inverness

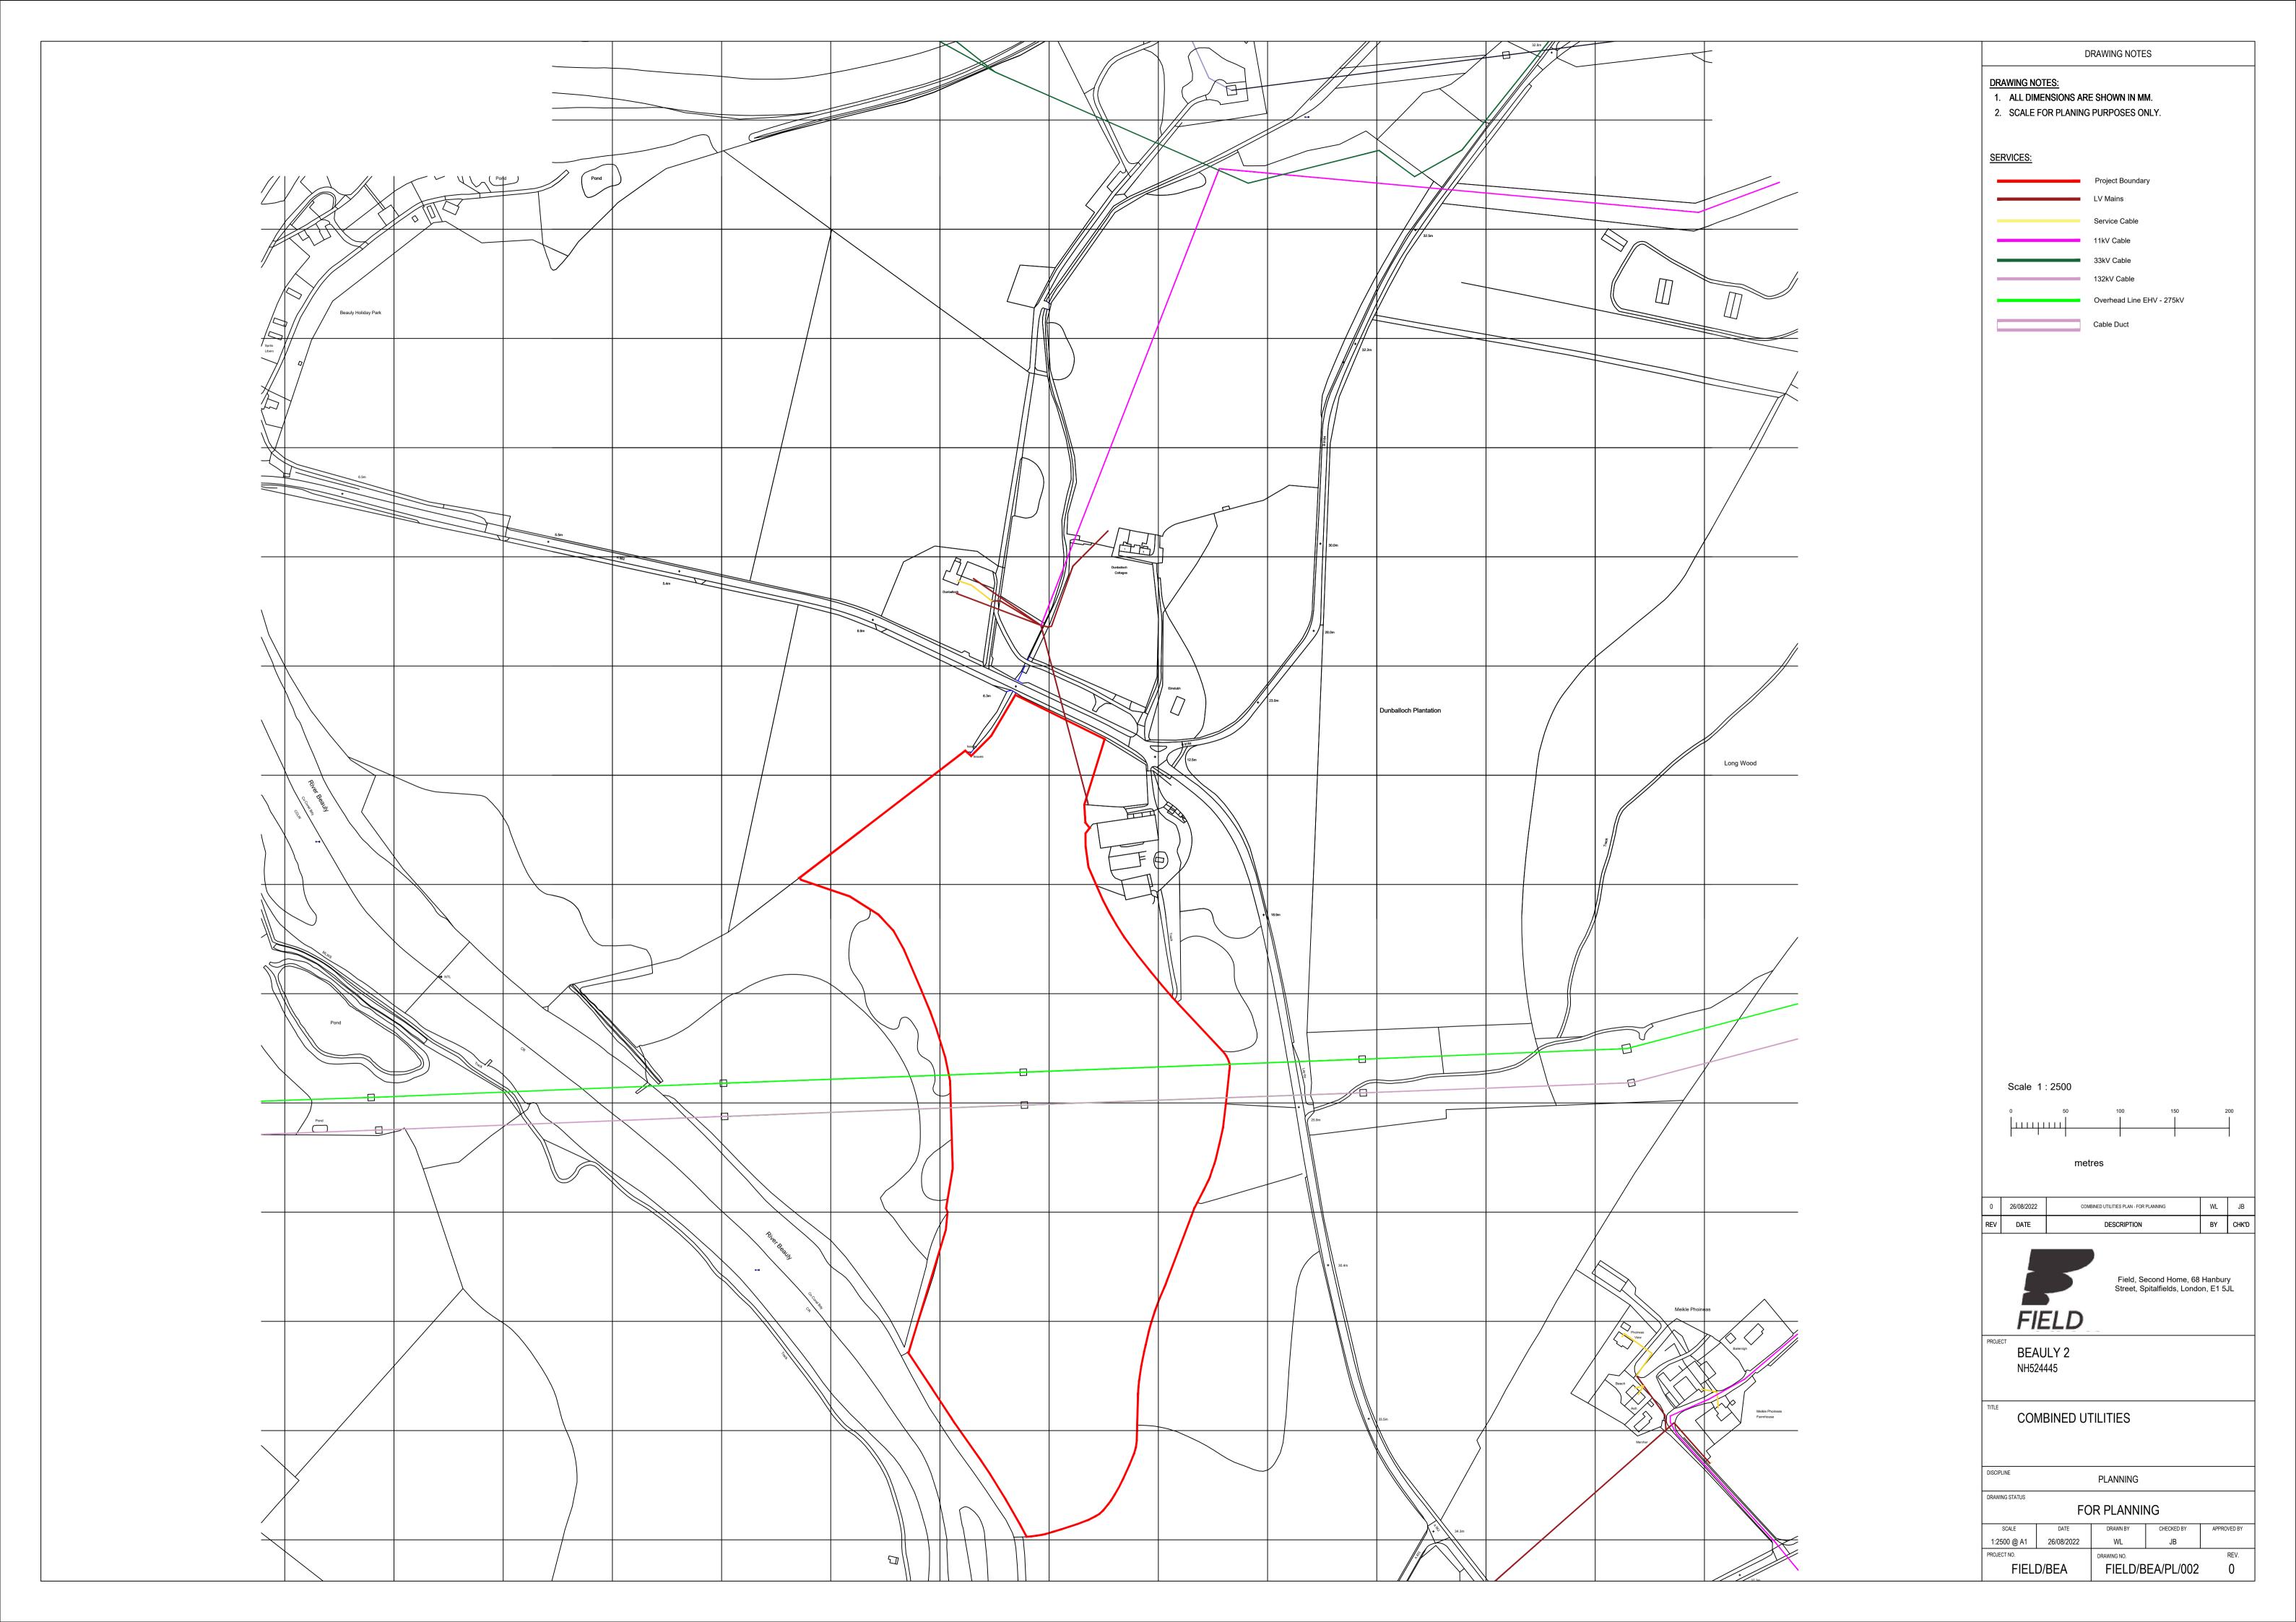
Field Combined utilities plan

A combined utilities plan has been produced for the site and this does not show any assets belonging to Scottish Water (SW), see Appendix B.

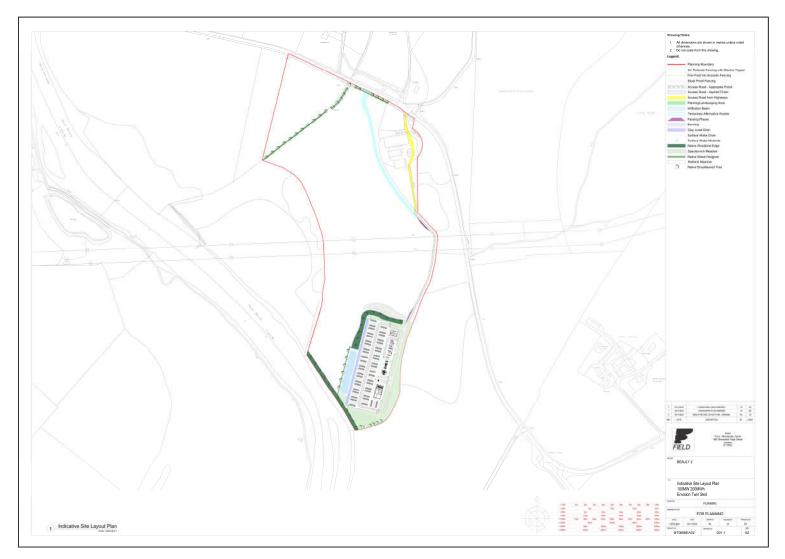
Figure 1-2: Beauly BESS 100 MW Proposed Development (Field 2024)

The Desk Study review is intended to inform the proposed development of a 100 MW battery energy storage system (BESS) 1.5 km to the east of the existing Beauly Substation. The proposed development comprises a BESS of up to 100 MW with associated infrastructure, earthworks, drainage, accesses and ancillary works (including landscaping and biodiversity enhancement). The proposed development is illustrated in Figure 1-2 below.
